EVALUATION OF THE

750,000 Gallon Steel Elevated Water Tank

Brazil, Indiana

March 22, 2004

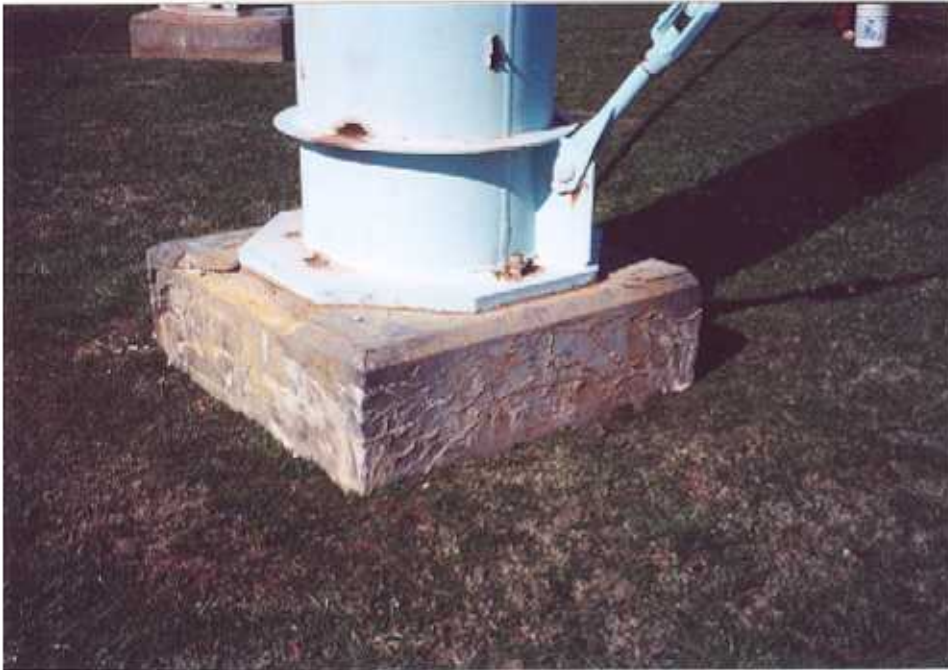
3. **Foundations:** Cracking and hollow sounding areas were observed in the exposed surfaces of the foundations at the time of this field evaluation. The top approximately 2 in. cap of the foundations for column #4, column #5, and the riser appeared to be delaminated concrete. The tops of the foundations generally met or exceeded the AWWA recommended projection of 6 in. to 12 in. above grade. A gray coating was visible on portions of the exposed concrete surfaces. There was no grout or sealant visible at the concrete foundation-to-base plate interfaces. (See photos 11-13)

11. Column foundation, base plate, and anchor bolt. Note cracks and chipped section of concrete.

3. **Foundations:** When the tank exterior is repainted, any unsound concrete should be chipped to sound material and the concrete should be brush-off blasted. Any reinforcing steel thus exposed should be cleaned prior to repairing the concrete. Any deteriorated areas or voids found should have a bonding agent and a vinyl emollient modified concrete patching mortar applied to build up the surface to its original contour. The concrete should then be painted with a concrete sealer. Any gap between the steel base plates and the concrete should be filled with a flexible sealant.

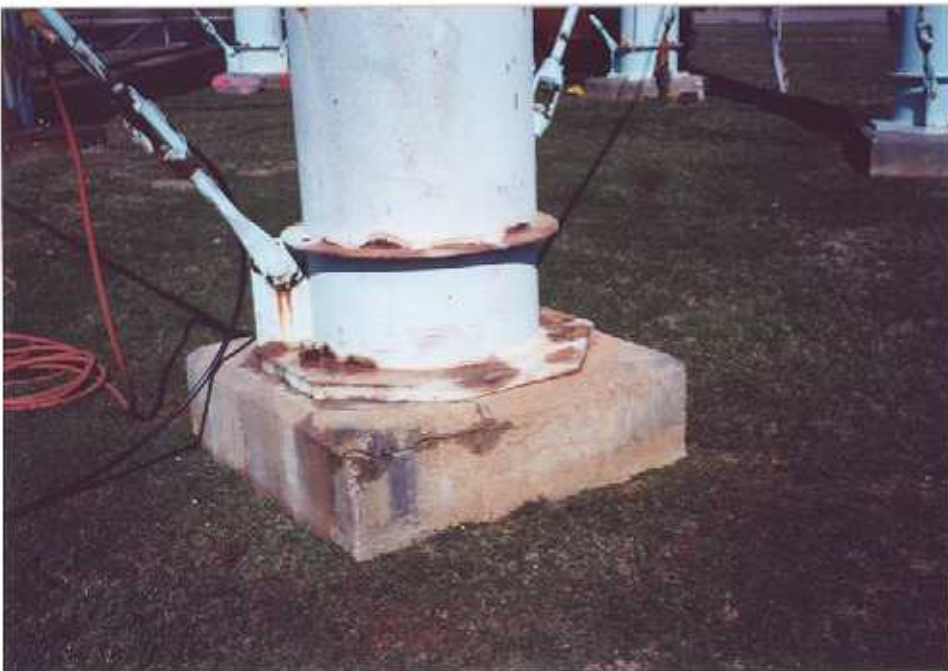
2. **Base Plates:** The column and riser base plates appeared to be in adequate overall condition at the time of the field evaluation. Widespread coating failures and rust were observed on the base plates. (See photos 11-13)

3. **Anchor Bolts:** Each of the columns was equipped with two anchor bolts, and the riser was equipped with four anchor bolts. Pack rust was noted on washers and at the bottom of nuts. (See photos 11-13)

12. Column foundation, base plate, and anchor bolt. Note crack in concrete and rust on base plate and anchor bolt.

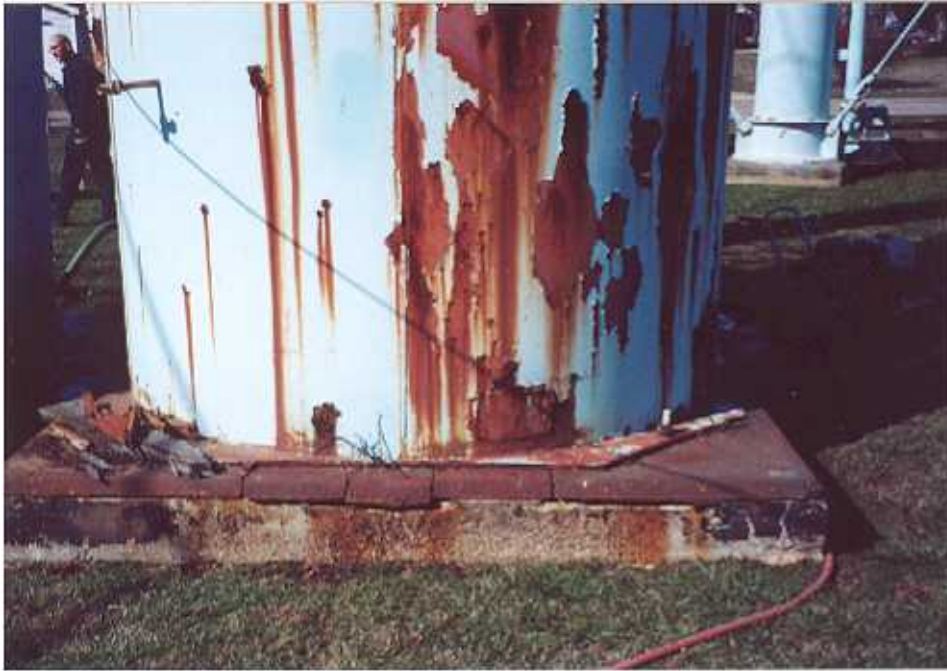
5. **Riser Condition:** The riser was of welded construction. The riser exterior appeared to be in nearly its original structural condition at the time of the field evaluation. Significant coating failure to rust and rust staining were observed on the riser. An overhead electrical line for the telemetry building west of the riser was in contact with the riser. The tank nameplate and a hose bib were located near the bottom of riser. The riser was equipped with a single-crab manhole. The riser around the manhole was not equipped with a reinforcing plate. The riser manhole cover was equipped with a hinged support on the interior. (See photos 13-15, 28-30)

13. Riser, foundation, base plate, and anchor bolts. Note cracks in cap on foundation, and note welded steel patch plate and hose bib in bottom of riser.

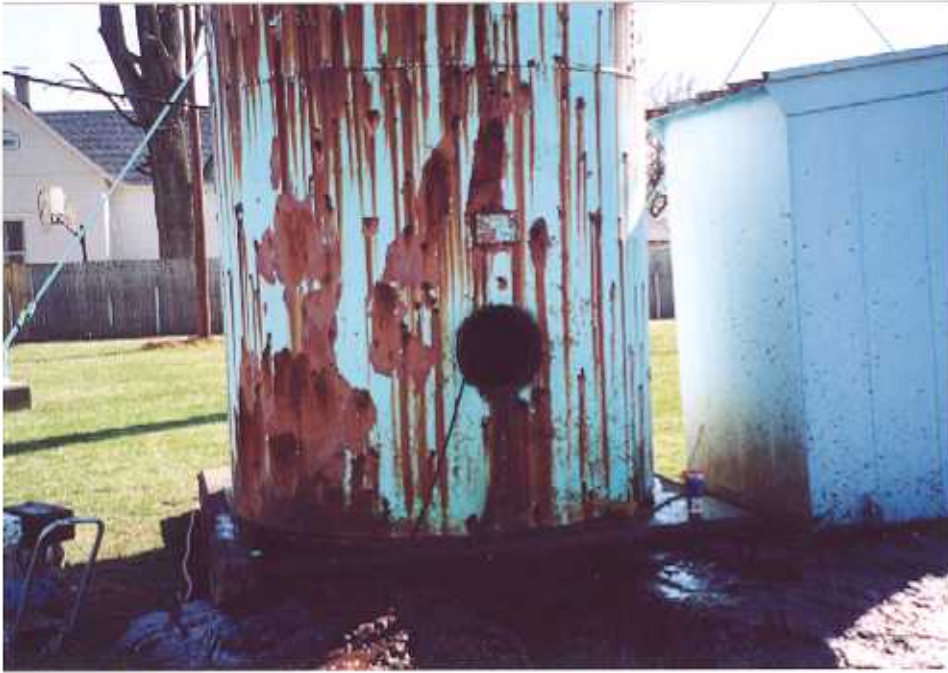
15. Riser, manhole, tank nameplate, and adjacent building. Note coating failures and corrosion on riser.

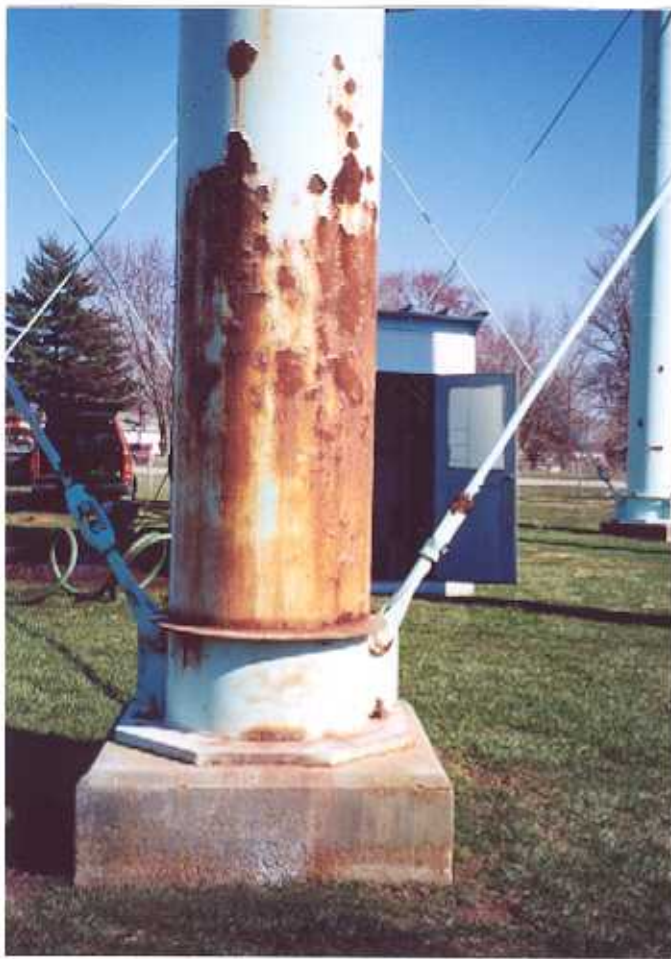
4. **Column Condition:** The columns were of welded steel construction and appeared to be in nearly their original structural condition at the time of the field evaluation. Widespread coating failure to the underlying coating and large areas of rust were observed on the columns. An abandoned cathodic protection system control cabinet was located near the bottom of column #1. There were hand holds located on the columns above the struts and directly beneath the bowl. **It is the opinion of Tank Industry Consultants that the hand holds should not be used for rigging purposes or personnel access.** (See photos 18-24)

19. Coating failures and rust on column.

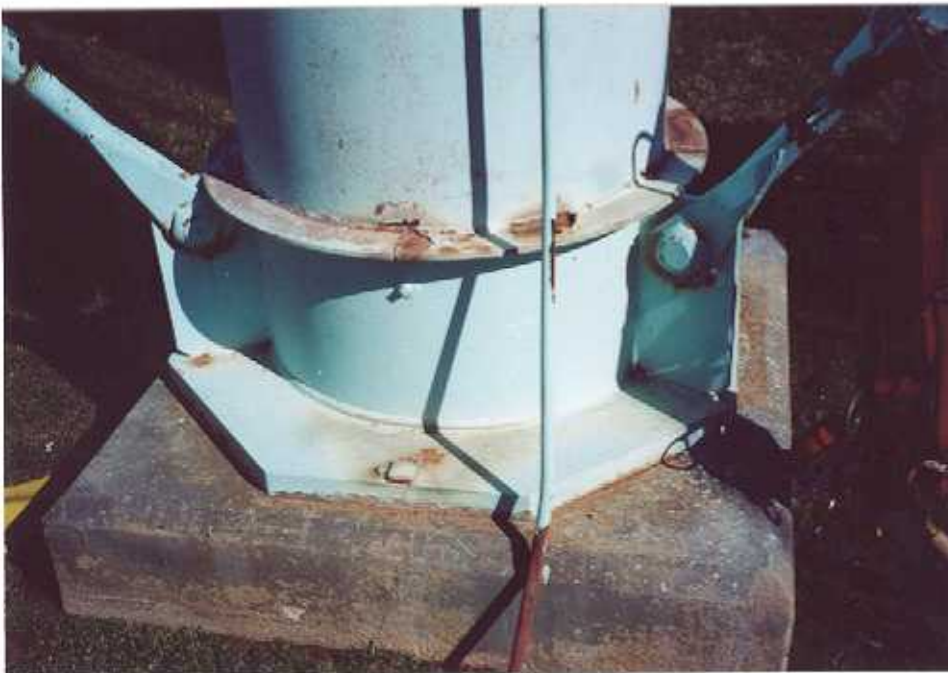
20. Coating failures and rust on plate around bottom of column. Note conduit.

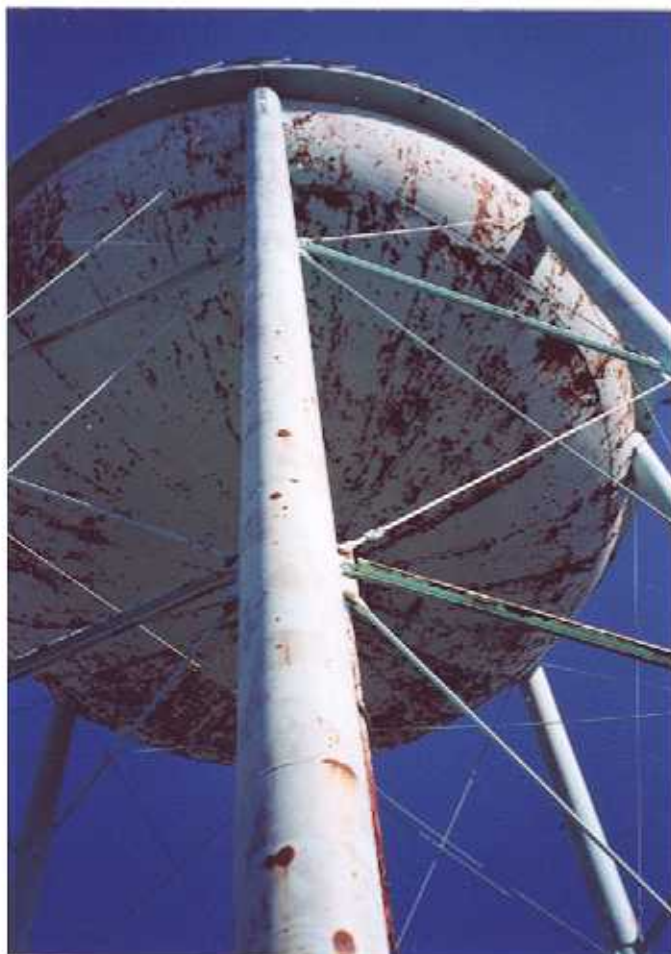
6. **Diagonal Bracing:** The coating system on the diagonal bracing appeared to be in very poor overall condition at the time of the field evaluation. The diagonal bracing rods were upset on the ends. The diagonal bracing was equipped with turnbuckles, clevises, and wing plates. Coating failures and rust were observed on the rods, turnbuckles, and inside the clevises. Rust staining was noted at the clevis connections to the wing plates. (See photos 22-27)

8. **Struts:** The tower was equipped with two sets of struts. The struts were bolted and welded to the wing plates. Coating failure and significant rust were observed on the struts. The struts were equipped with drain holes. (See photos 22-26)

22. Column, struts, diagonal bracing, and bowl. Note rust.

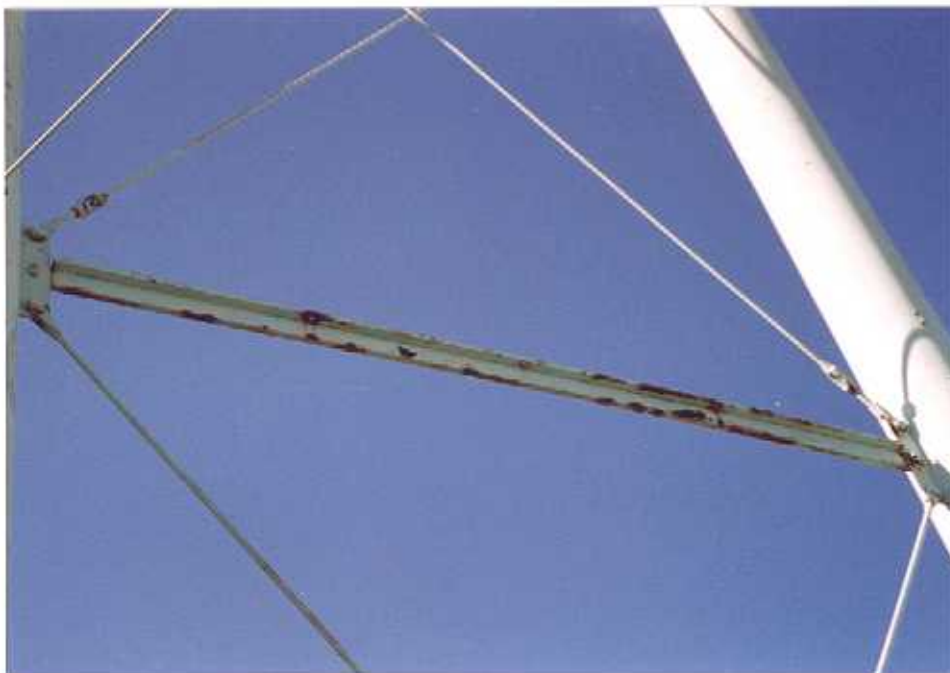
24. Rust along underside of strut.

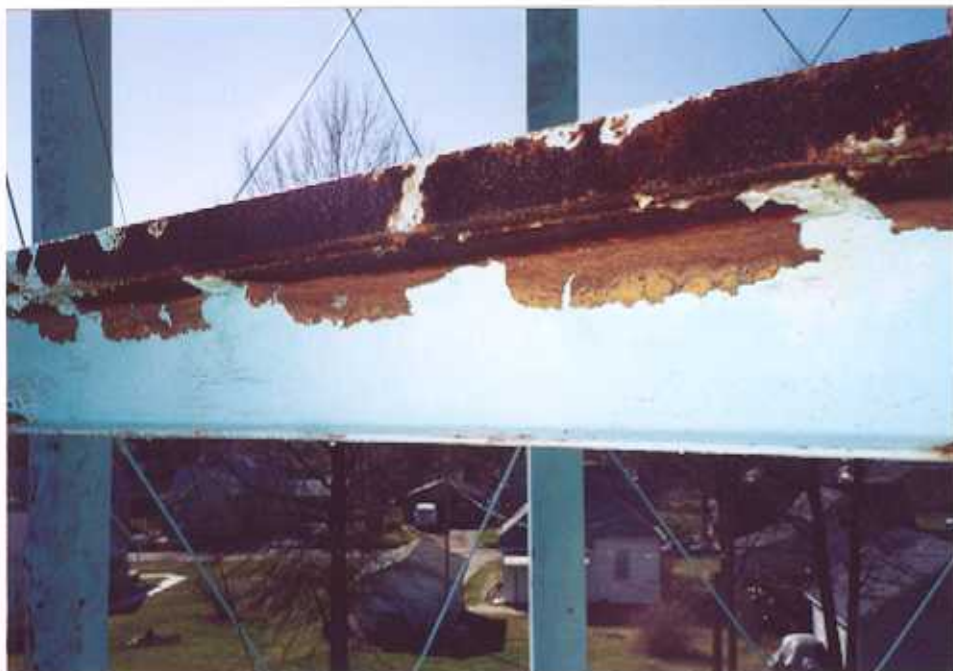
25. Rust along strut.

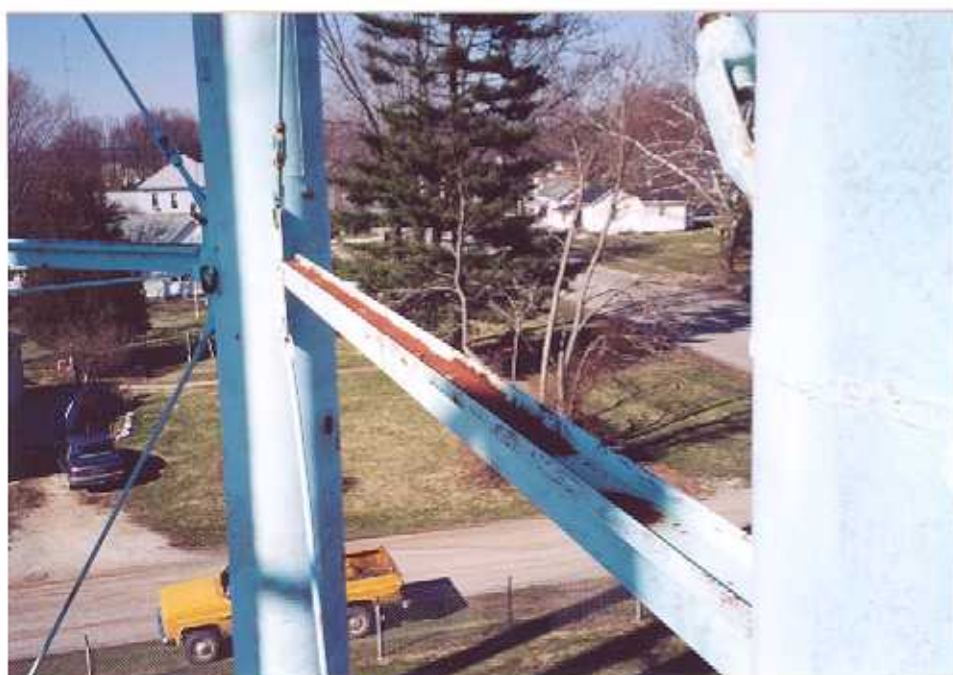
26. Rust inside strut channel.

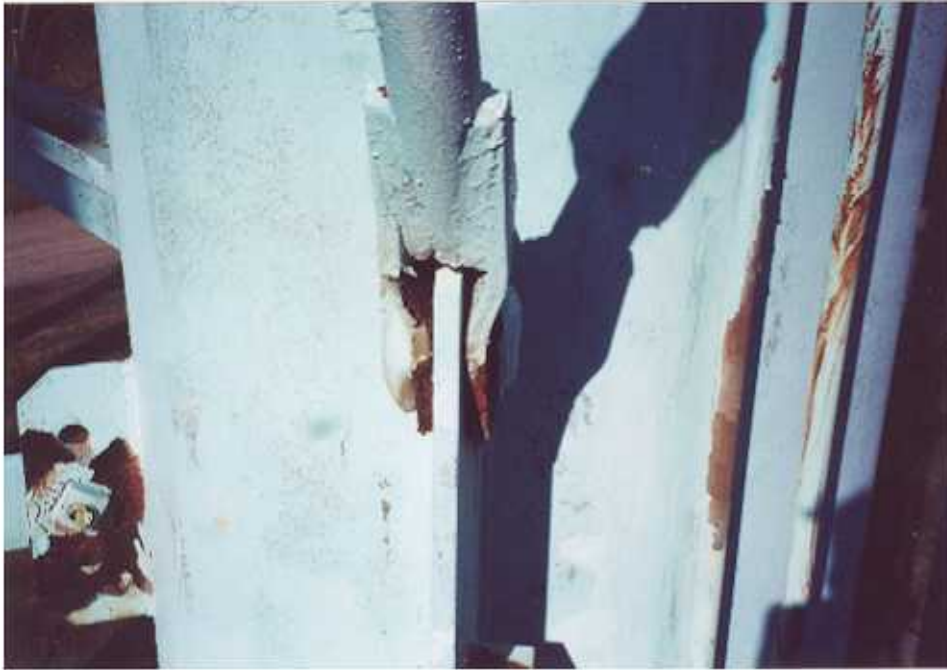
27. Rust at diagonal bracing clevis connection to wing plate on column.

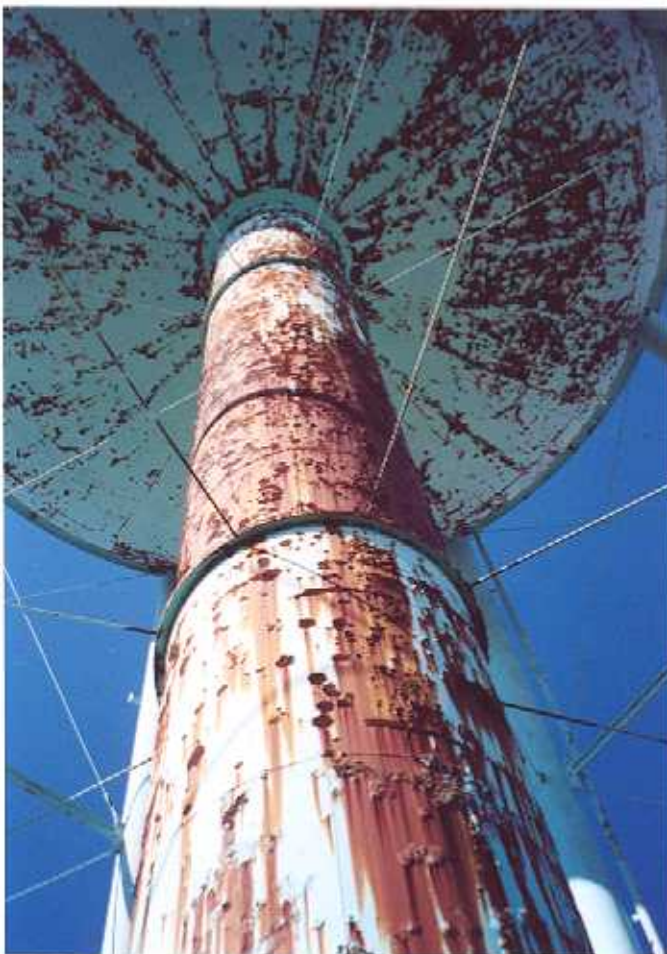
7. **Riser Rods:** The tower was equipped with two sets of riser rods which were located at the strut levels. It appeared that a third level of riser rods just below the bowl had been removed. The riser rods were bolted through angles located around the riser. Surface rust was observed on the rods. **It is the opinion of Tank Industry Consultants that the riser rods should not be used for rigging purposes or personnel access.** (See photo 28)

28. Coating failures, rust, and rust staining on riser and riser rods.

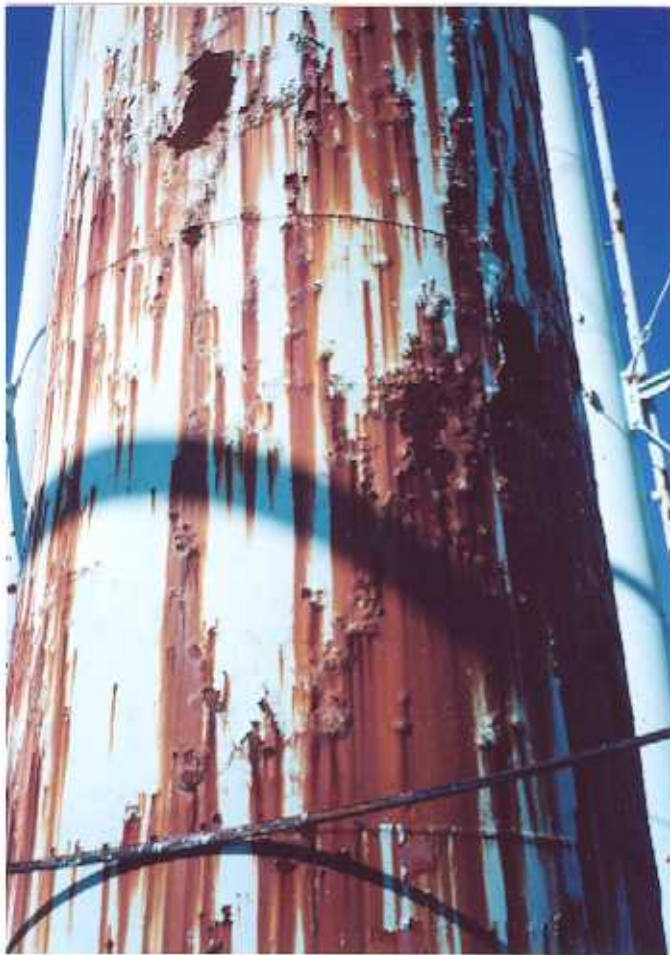
29. Coating failures, rust, and rust staining on riser and riser rods. Note overhead electrical line for telemetry building adjacent to riser.

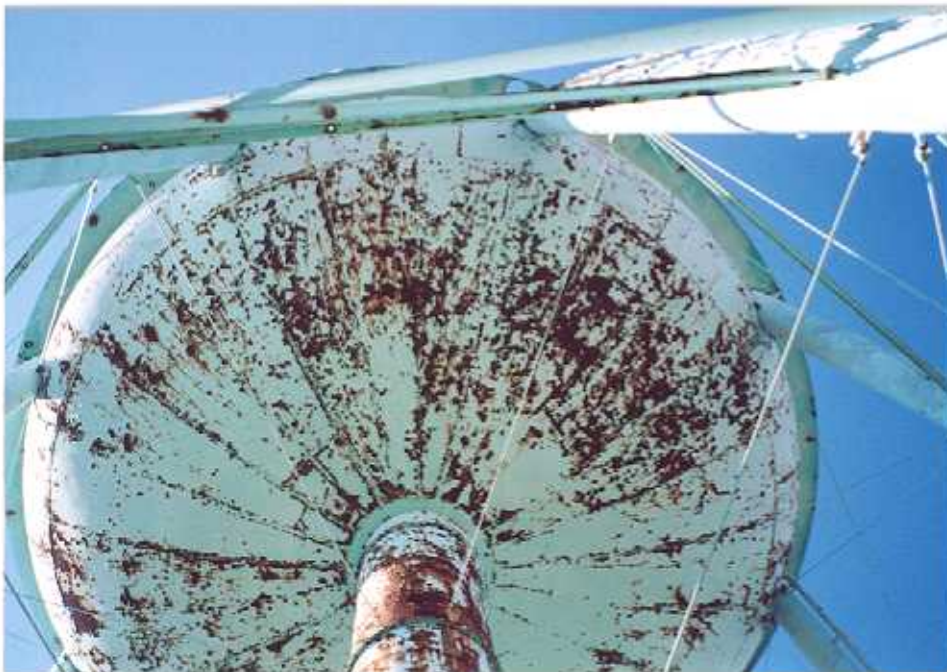
11. **Bowl Condition:** The coating on the bowl surfaces appeared to be providing very poor overall corrosion protection. Large areas of coating failure and rust were observed. (See photos 30-32)

30. Coating failures and rust on riser and bowl.

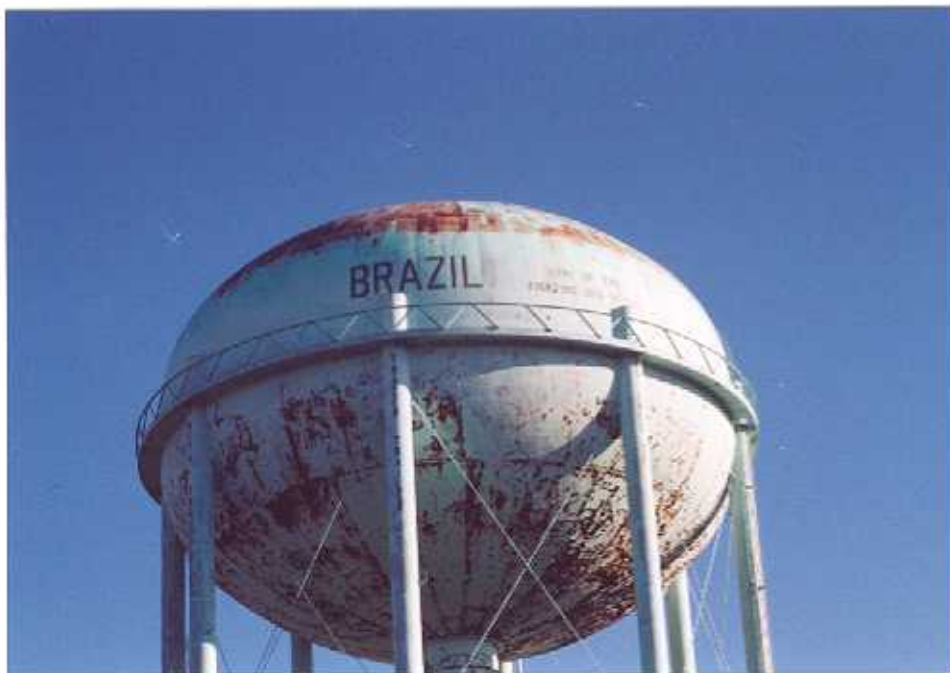
14. **Signs:** There were company names in approximately 5 in. wide letters painted vertically on each column and on the east side of the riser. "BRAZIL" in approximately 4 ft tall letters was painted on the south side of the shell. "HOME OF THE FIGHTING RED DEVILS" in approximately 6 in. wide letters and "TOWN OF PROGRESS" in approximately 9 in. wide letters were painted on the shell. "PROGRESS" was misspelled, missing an "R," in this sign on the east side of the shell. "BRAZIL IND." and "AIRPORT 3 MI." with an arrow had been painted on the roof of the tank. The signs were in black letters. The signs had faded. (See photos 1-2, 18, 31-32, 40, 42, 50)

32. Signs on container and columns. Note widespread rust.

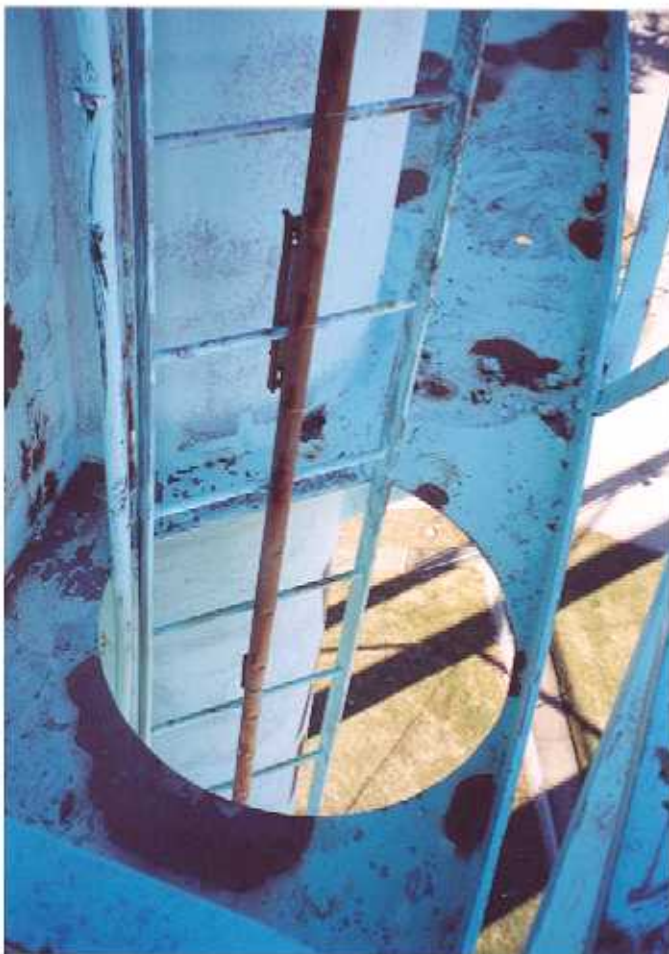
10. **Tower Ladder:** There were safety and OSHA deficiencies noted: (1) the rust and paint on the safe-climbing device may not allow the device to function properly, (2) the width between side rails of 15 in. did not meet the required 16 in. minimum, (3) the 6 in. toe room did not meet the required 7 in. minimum, (4) the 2 in. x 5/16 in. side rails did not meet the required minimum of 2-1/2 in. x 3/8 in. side rails, (5) the 5/8 in. diameter ladder rungs did not meet the required minimum ladder rung diameter of 3/4 in., (6) the rungs were not of a slip-resistant design, (7) the ladder was not equipped with a vandal deterrent, (8) a conduit and a cable were attached to the ladder brackets which could interfere with the unrestricted use of the side rails by the climber, and (9) the 19 in. head clearance at the balcony access did not meet the required 30 in. minimum. The tower was equipped with a ladder which provided access from near grade to the balcony. The tower ladder was equipped with a notched-tubular safe-climbing device. The tower ladder was bolted to brackets which were welded to the column. The tower ladder and brackets appeared to be in nearly their original structural condition at the time of this field evaluation. (See photos 33-36)

36. Tower ladder access to balcony. Note rust on safe-climbing device and conduit and cable along ladder side rail.

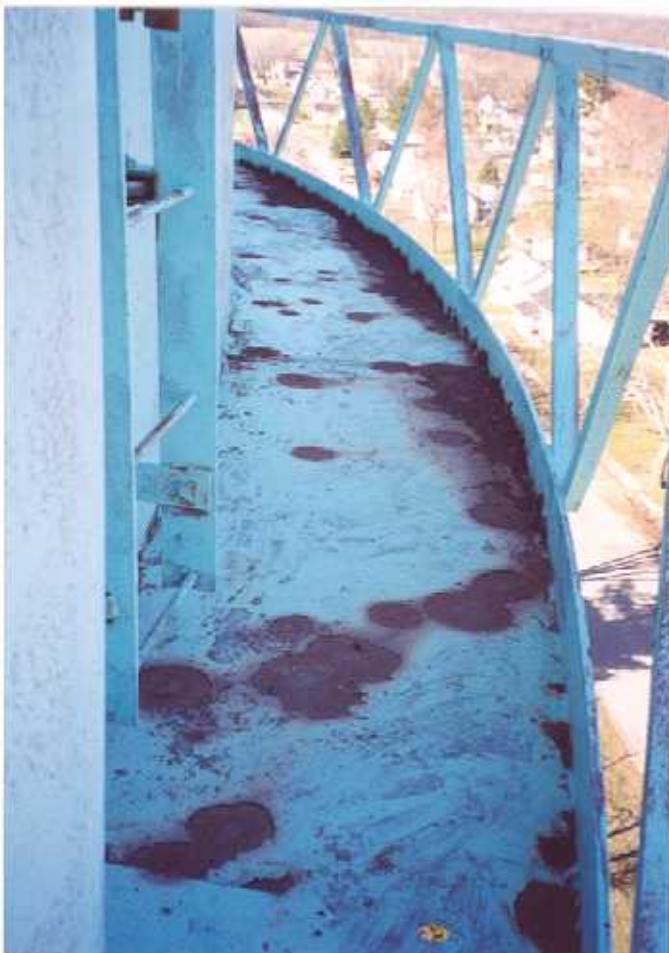
12. **Balcony Condition:** There were safety and OSHA deficiencies noted: (1) the 35-3/4 in. handrail height did not meet the required 42 in. minimum, (2) the safety railing was not equipped with a mid-rail, and (3) the 2 in. x 2 in. x 3/16 in. diagonal bracing did not comply with the required 2 in. x 2 in. x 3/8 in. Access to the balcony from the tower ladder was through an opening in the balcony floor. An angle was installed on the balcony adjacent to the opening in the floor to prevent personnel from walking directly into the opening. The access width on the balcony between this angle and the shell was approximately 12 in. The balcony floor was equipped with drain holes; however, evidence of trapped water was found on the balcony near the shell and toe bar. The underside of the balcony floor was intermittently welded to the shell and toe bar. The safety railing was of welded and bolted construction. Widespread coating failures and rust were observed on the balcony floor. (See photos 36-39)

38. Rust on balcony floor.

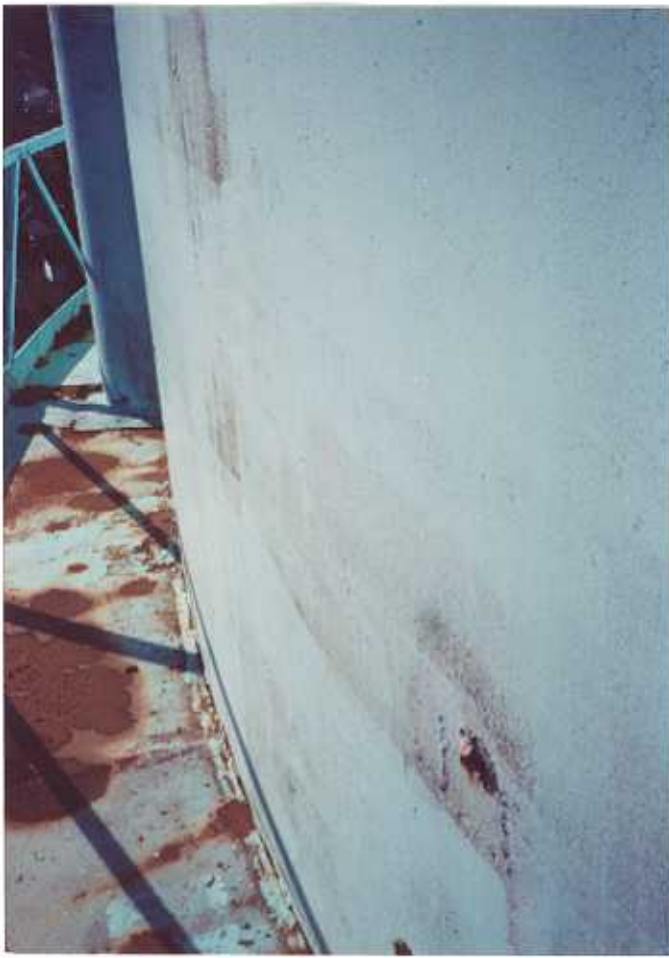
13. **Shell Condition:** The contour of the tank shell appeared to be good as no significant discontinuities were observed at the time of this field evaluation. Significant chalking, peeled topcoat, and areas of rust were observed on the shell. Scratches were noted in the shell coating from the wheels of the revolving shell and roof ladder. A circular welded steel patch plate was located in the northwest side of the shell. (See photos 39-42)

39. Rust on balcony floor and chalked coating on shell.

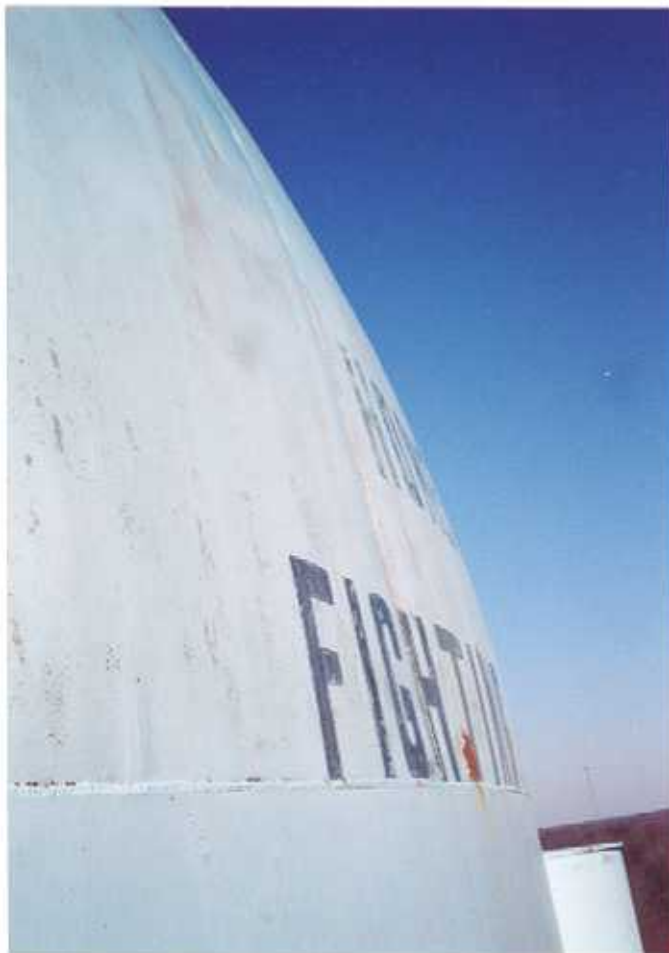
40. Faded sign on container.

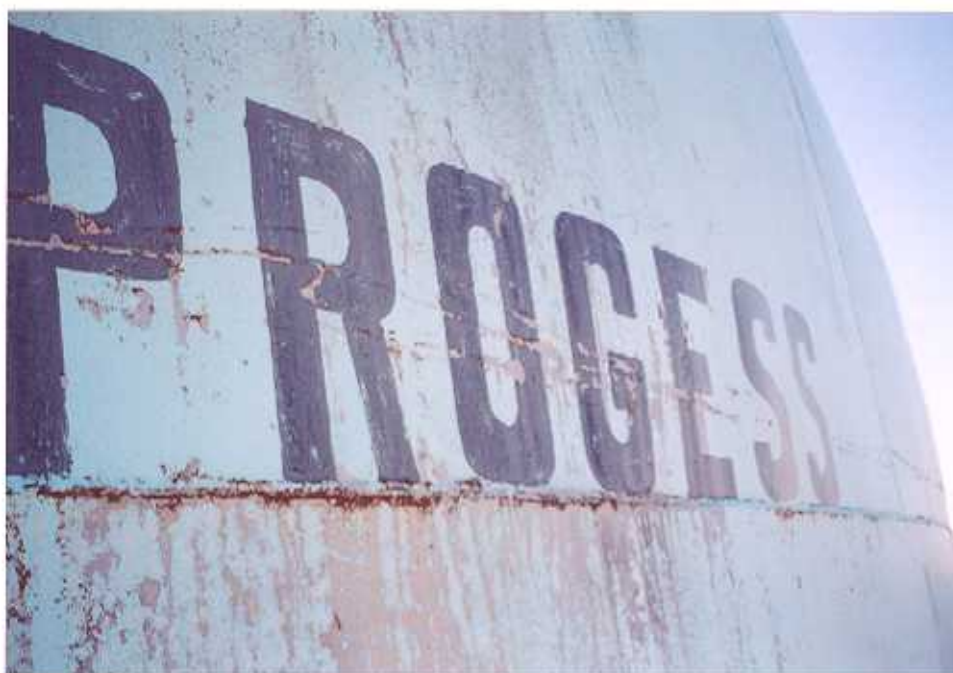
41. Scratches in coating from wheels of revolving shell and roof ladder. Note misspelling of "PROGRESS."

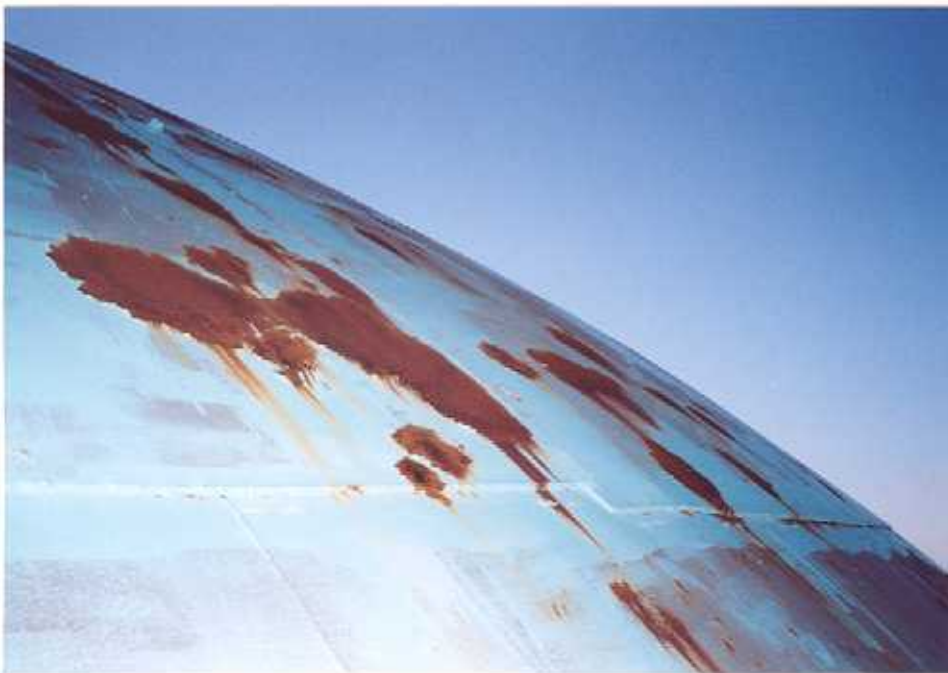
16. Roof Condition: The contour of the roof appeared to be adequate at the time of this evaluation. The coating on the roof had experienced significant chalking and erosion exposing the underlying coating. Large areas of rust were observed on the roof. There were approximately seventy 2 in. diameter couplings located in the roof plates. Approximately 9 cathodic protection anode hand holes and cover plates were located in the roof plates. One of the cover plates was welded to the roof. (See photos 44-50)

44. Coating failures and rust on roof.

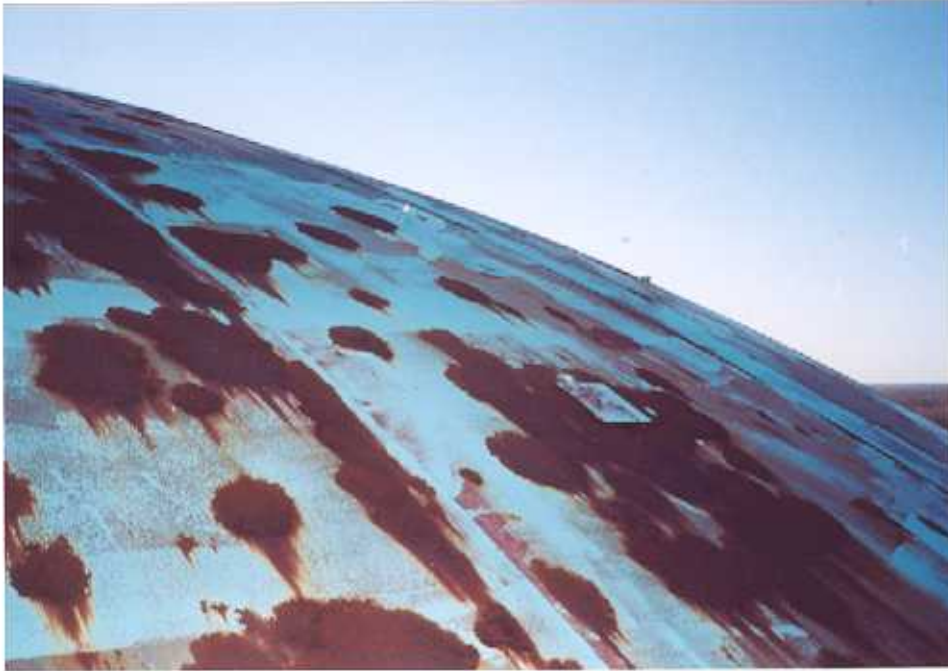
45. Coating failures and rust on roof.

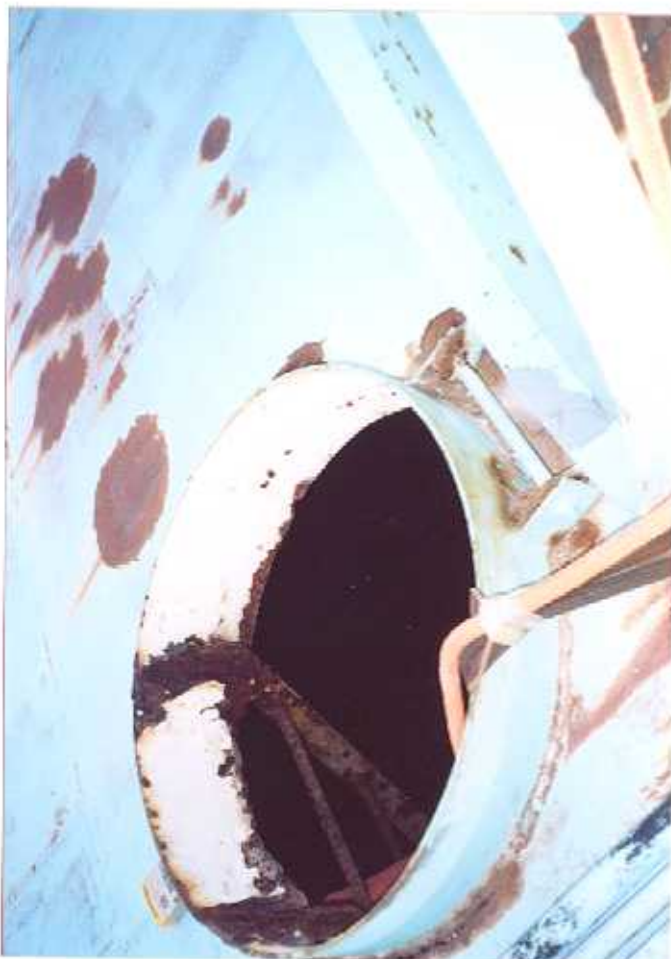
18. Roof Manhole: There was a sanitary deficiency noted: **corrosion had created holes in the roof along the curb of the roof manhole which would allow the ingress of insects and precipitation into the tank.** The roof was equipped with one manhole. The manhole was equipped with a hinged and locked cover. The existing lock was cut off prior to the field evaluation and a new lock provided by the Owner was installed after the field evaluation. The roof manhole was welded on the exterior only. (See photo 46)

46. Roof manhole. Note corrosion on manhole curb and interior ladder and holes in roof adjacent to manhole.

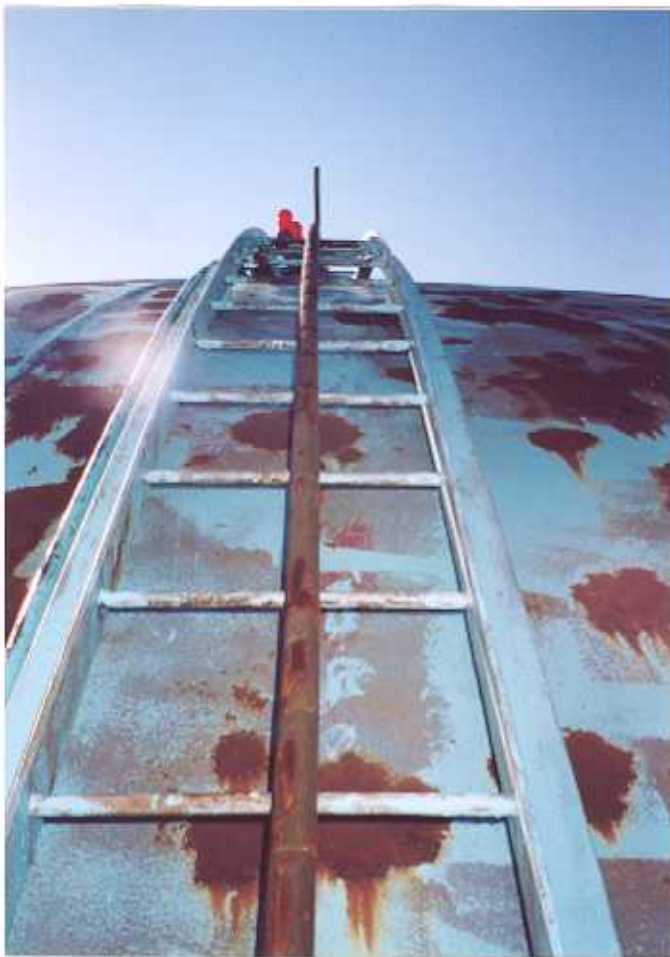
15. **Exterior Shell and Roof Ladders:** There were safety and OSHA deficiencies noted: (1) the rust on the safe-climbing device may not allow the device to function properly, (2) the 13 ft or greater spacing of the safe-climbing device clamps did not meet the manufacturer's recommendation, (3) the revolving-type shell and roof ladder was supported by a single-point of

47. Shell and roof ladder.
Note rust on safe-climbing device and conduit and cable along ladder side rail.

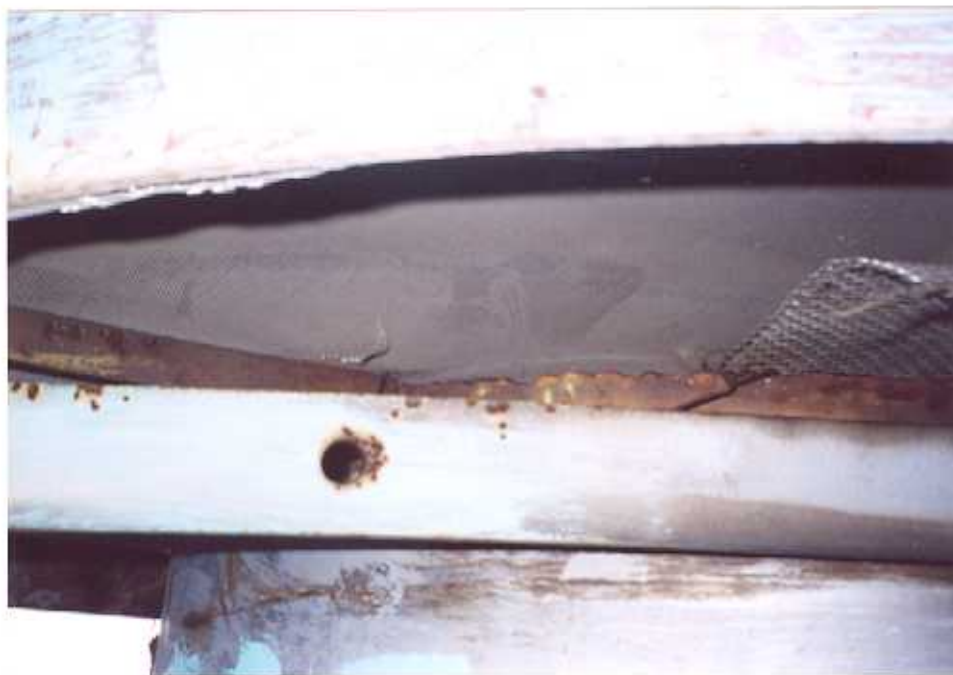
19. Roof Vent: There were sanitary and operational deficiencies noted: **(1) the roof vent was not of a clog-resistant design, (2) the sections of 4 x 4 mesh protective screening on the roof vent were not restrictive enough to prevent the ingress of insects into the tank, and (3) gaps between the screen and the vent neck would not prevent the ingress of insects into the tank.** The roof was equipped with a vent in the approximate center of the roof. Sections of 4 x 4 mesh screen had been used to patch holes in the 16 x 16 mesh vent screen. An antenna mounting bracket, but no antenna, was located on the roof vent cover. A cathodic protection hand hole was located in the vent cover. (See photos 48-50)

49. Roof vent screen.

19. **Clog-Resistant Vent:** The tank was not equipped with a clog-resistant vent. AWWA Standards recommend that all vents with screening against insects be designed to ensure "fail-safe"

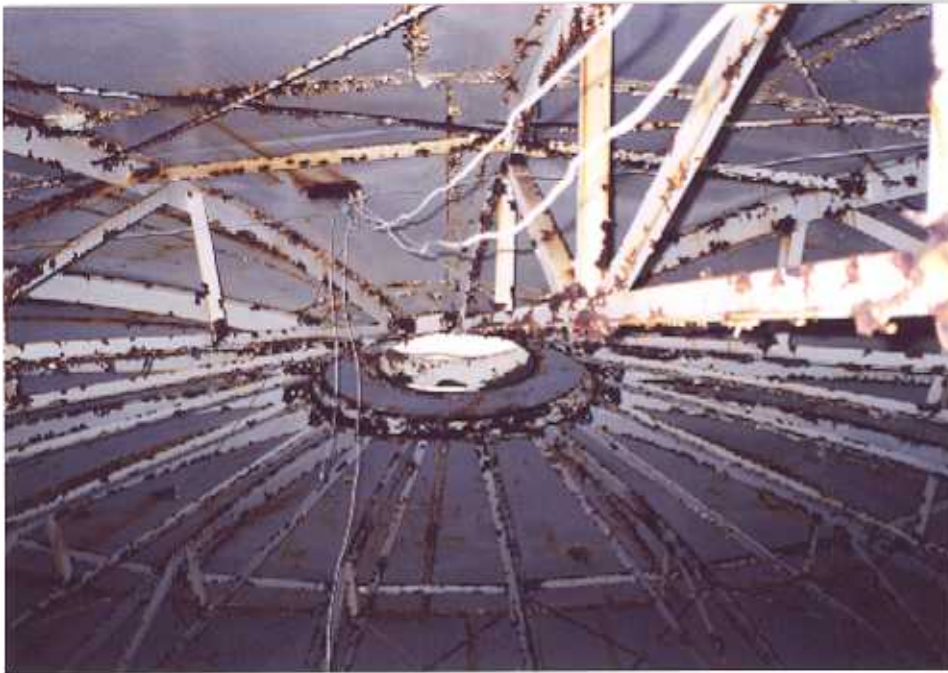
2. **Roof Condition:** The coating on the roof plates and roof structure appeared to be in very poor condition. The interior roof support structure consisted of radial roof trusses and intermittently welded stiffeners on the roof knuckle. The inner ends of the roof trusses were bolted to clips welded to a center hub. The outer ends of the roof trusses were bolted to plates welded to the roof knuckle stiffeners. Corrosion and metal loss were observed along the truss members and at the bolted connections. Wiring for a cathodic protection system was located in the roof of the tank. There were no anodes in the tank at the time of this field evaluation. (See photos 51-64)

51. Interior roof structure and cathodic protection wiring. Note rust on roof and trusses.

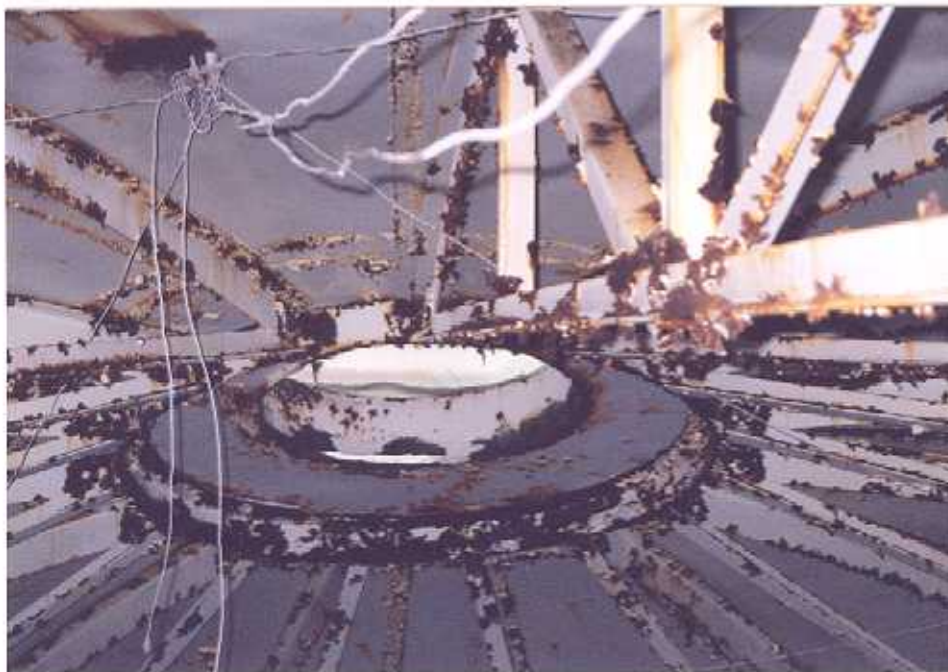
52. Vent opening, interior roof structure and cathodic protection wiring. Note rust on roof and trusses.

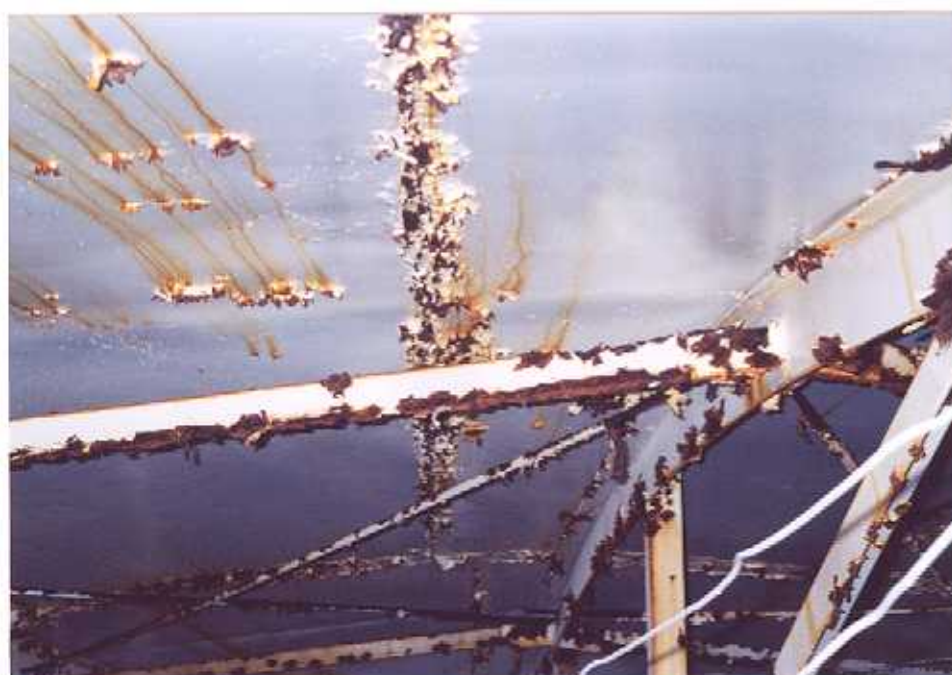
54. Peeled coating and corrosion on roof and along truss members.

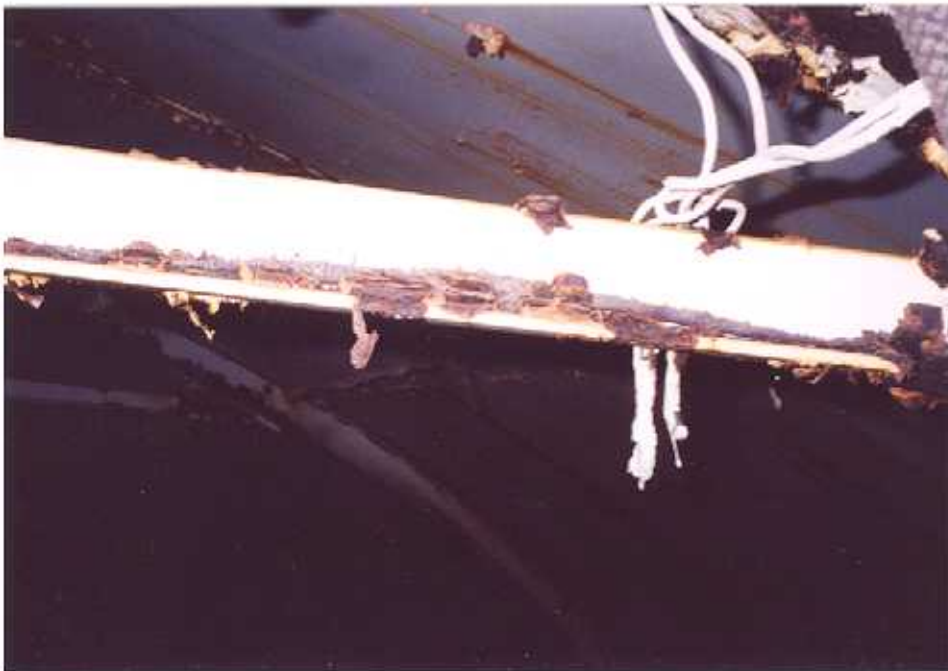
56. Corrosion along roof truss member.

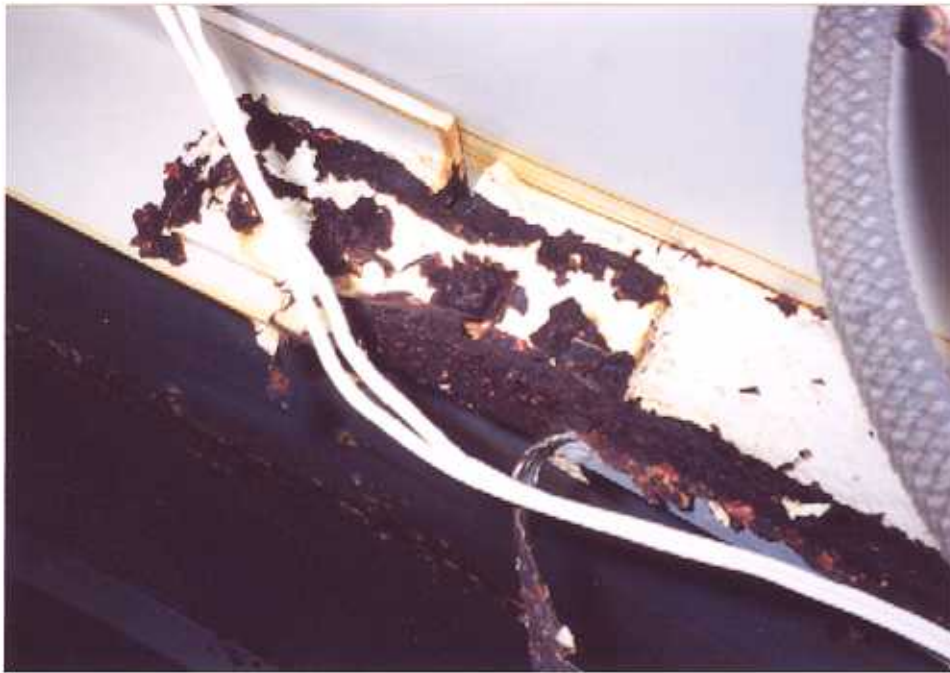
57. Corrosion along roof truss member.
